INDOOR AIR QUALITY ASSESSMENT

**Holbrook Junior/Senior High School
245 South Franklin Street
Holbrook, MA 02343**

Prepared by:
Massachusetts Department of Public Health
Bureau of Environmental Health
Indoor Air Quality Program
March 2008

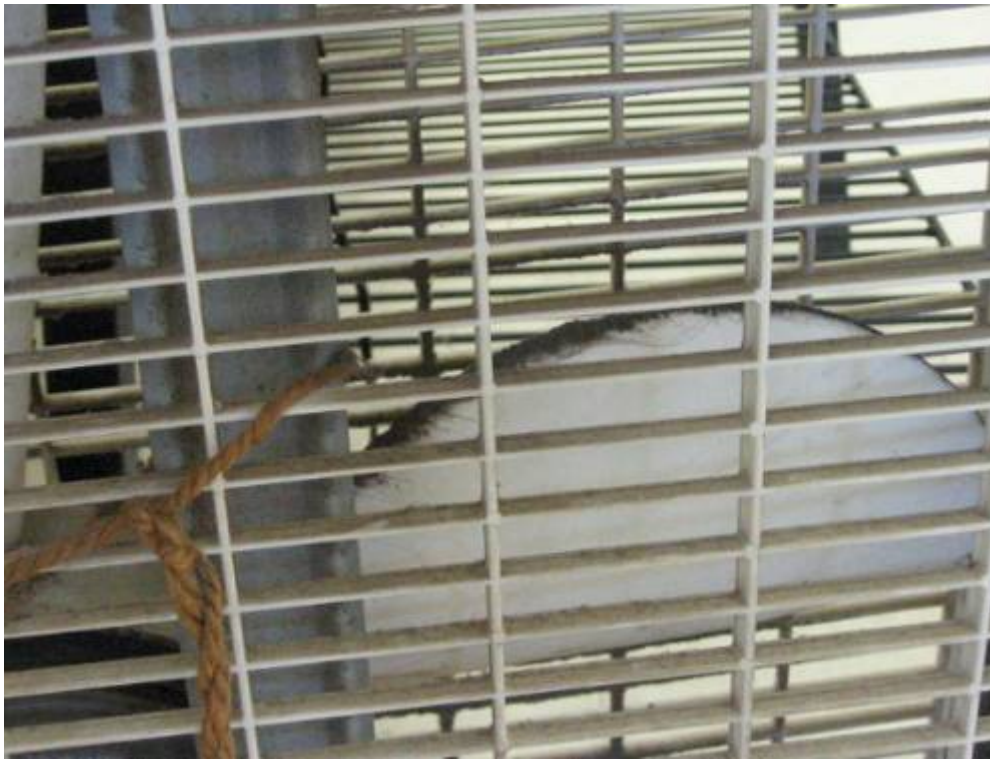
Picture 27

A number of exhaust/return vents, univent supply vents and personal fans (Picture 26 and 27) were observed to have accumulated dust. If exhaust vents are not functioning, backdrafting can occur, which can re-aerosolize accumulated dust particles. Re-activated univents and fans can also aerosolize dust accumulated on vents/fan blades.

Accumulated Dust/Debris on Personal Fan

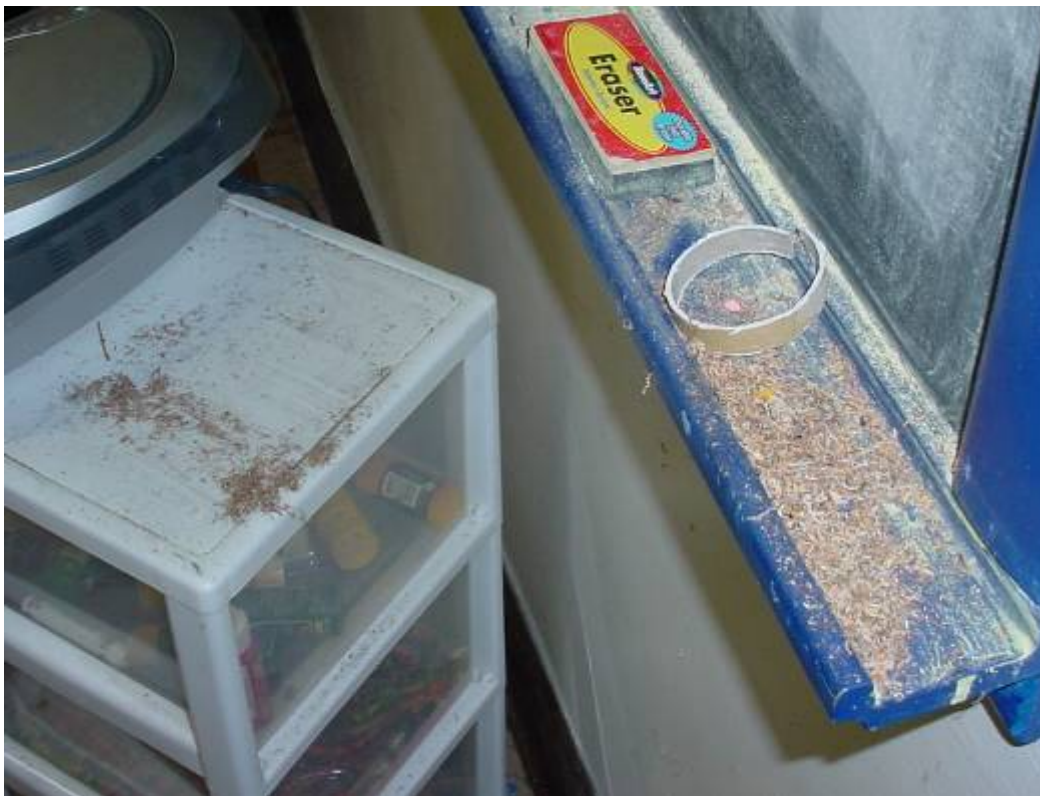
Picture 28

An accumulation of chalk dust, pencil shavings and dry erase particulate was observed in some classrooms (Picture 28). When windows are opened or univents are operating, these materials can become airborne. Once aerosolized, they can act as irritants to eyes and the respiratory system.

Accumulation of Chalk Dust and Pencil Shavings

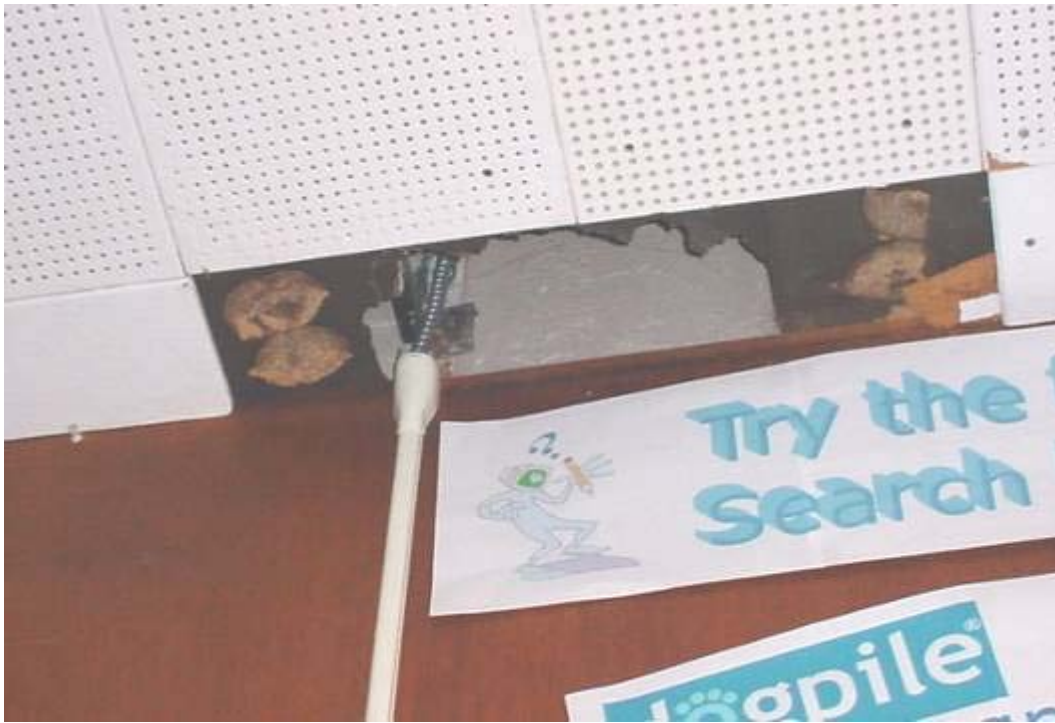
Picture 29

Open utility holes and missing ceiling tiles were observed in the library (Picture 29) and other areas (Table 1), which can provide pathways for drafts, dust and particulates to

Missing Ceiling Tile in Library

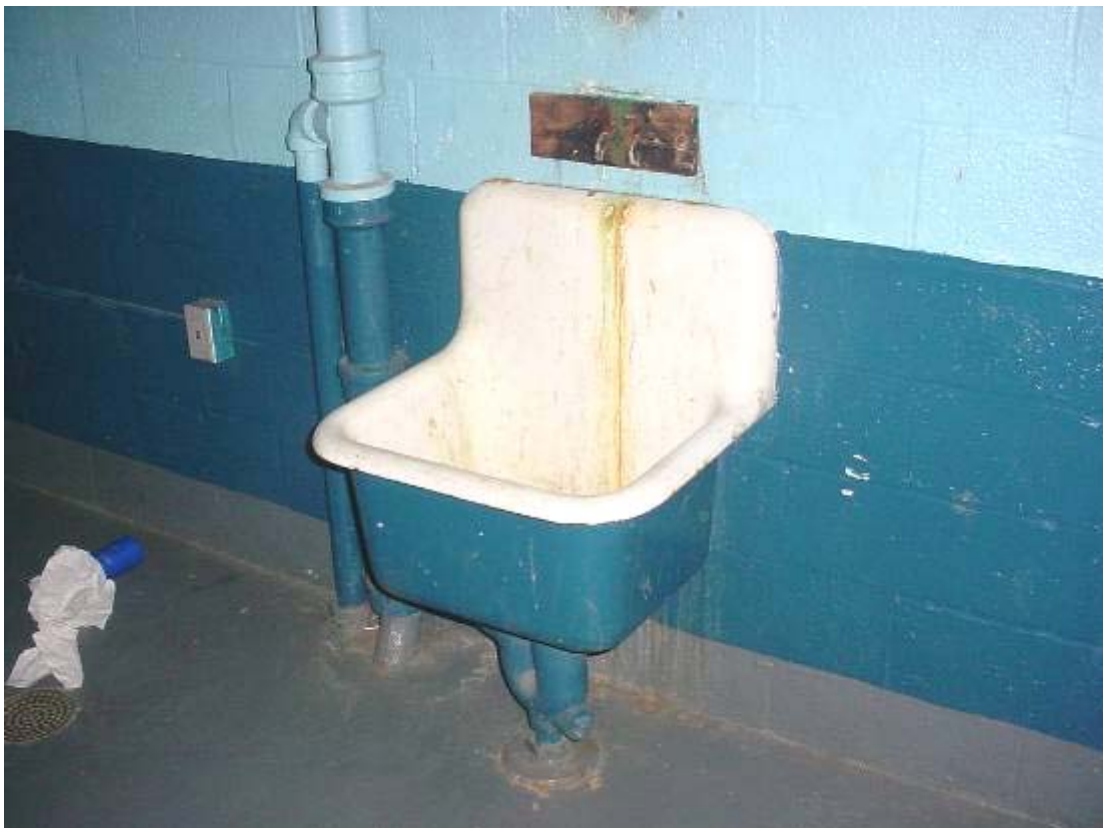
Picture 30

In both the boys' and girls' locker rooms, abandoned sinks and decommissioned showers were noted (Picture 30). In addition, emergency safety showers and eyewash stations were observed. One particular eyewash station was sealed. The traps for these drains can dry out which can lead to sewer gas odors penetrating the room through unsealed traps. Sewer gas odors can be irritating to the eyes, nose, and throat.

Abandon Sink in Locker Room

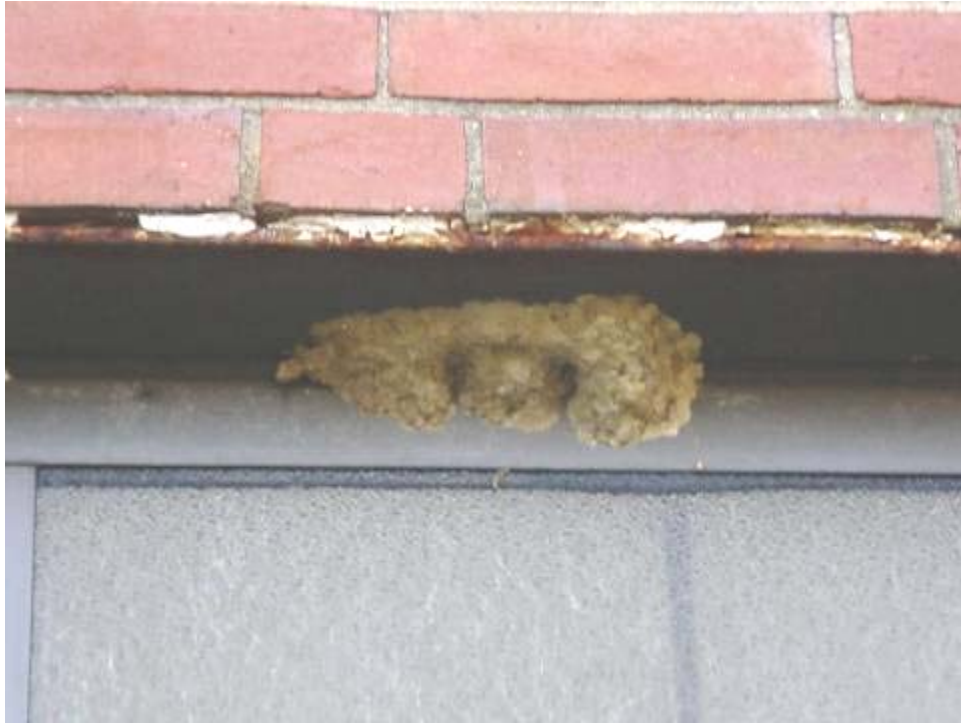
Picture 31

Insect Nest above Window on Exterior of Building
